Report on the Quinquennial Survey for 2026

Church of the Ascension

QUINQUENNIAL INSPECTION REPORT

Date of Inspection: 13th March 2026

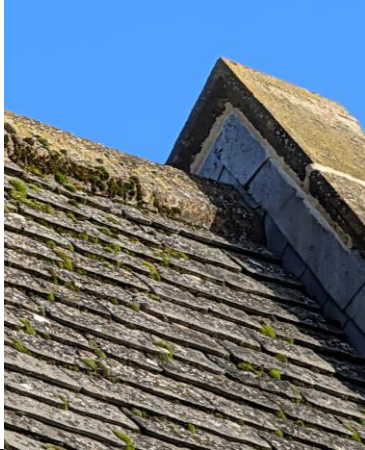
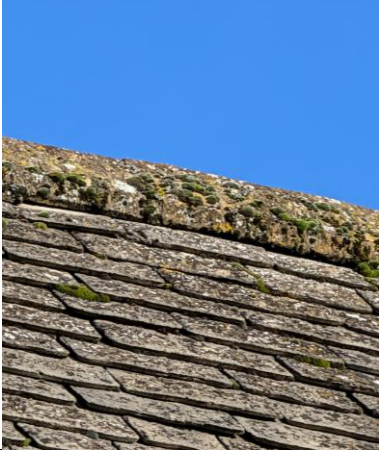
Left 1a
--	--	---------

- 6.3. The ridge line is formed in stone with mortar bedding, which shows signs of erosion and opening of joints. Localised vegetation growth is present within these joints, indicating moisture retention and progressive loss of bedding integrity. Re-bedding in lime mortar will be required in the medium term to maintain stability and weather resistance. (Photo 1a & 1b)

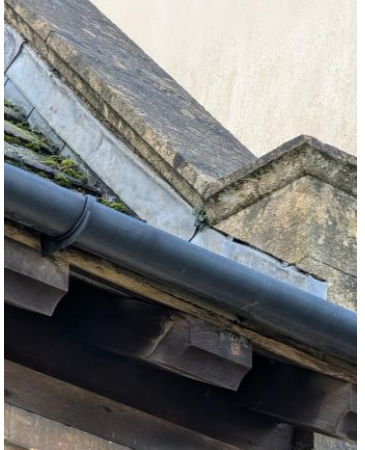
<p>Left 2a</p>
		<p>Right 2b</p>

- 6.8. Gutters show signs of wear and localised leakage at joints, which may contribute to saturation of the wall head and adjacent masonry. Regular clearance and repair of rainwater goods should be prioritized. (Photo 2a)

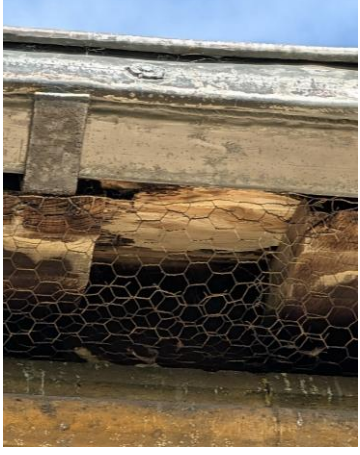
<p>Left 3a</p>
		<p>Right 3b</p>

- 6.11. The abutment with the adjacent wall incorporates lead flashing, which appears intact but aged. Vegetation growth is evident at the junction, particularly at the upper corner, suggesting a build-up of debris and potential restriction to water runoff. Clearance and repointing of the flashing is recommended to ensure continued weathering performance. (Photo 3a)

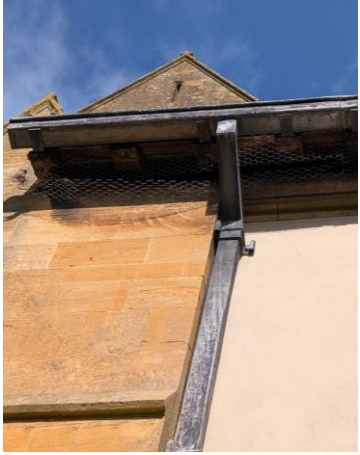
<p>Left 4a</p>
		<p>Right 4b</p>

- 6.19. At eaves level, timber elements beneath the gutter line show signs of moisture staining and localised decay, consistent with intermittent leakage or overspill from the rainwater goods. In isolated areas, timber ends are weathered and softened, suggesting prolonged exposure. (Photo 4a)

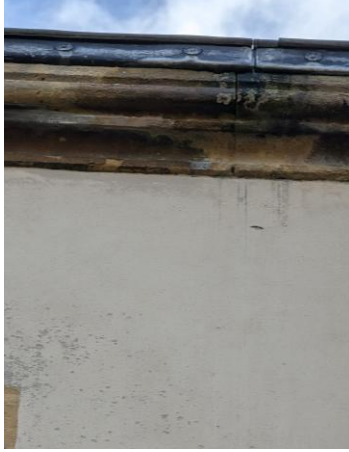
<p>Left 6a</p>
		<p>Right 6b</p>

- 6.31. Biological growth, predominantly lichen with some localised moss, is present across the surface and more concentrated toward the upper courses and in the vicinity of the ridge and at the eaves. This reflects prolonged exposure and contributes to gradual surface degradation of the stone slates. (Photo 6a)

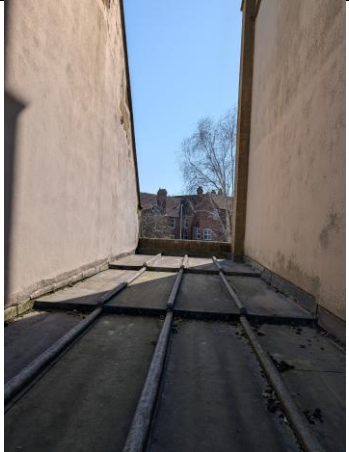
<p>Left 7a</p>
		<p>Right 7b</p>

- 6.37. Open joints and signs of water staining suggesting leaking or overtopping of the gutter. Observation in heavy rainfall would be beneficial. (Photo 7a)
- 6.38. A further close inspection is recommended, either by drone survey or safe access, to verify the condition of this roof slope and to inform any necessary maintenance or repair works.
