Report on the Quinquennial Survey for 2026

St. Matthias, Malvern Link

QUINQUENNIAL INSPECTION REPORT

Church Name: Church of St Matthias

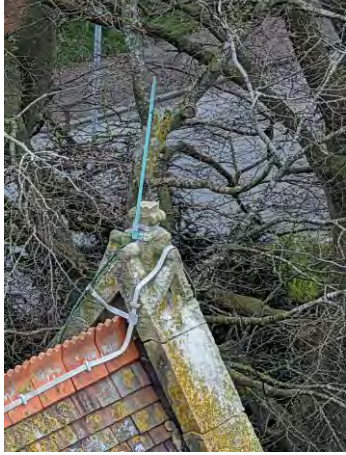
- 6.22. The decorative stone cross to the east gable parapet has fractured and failed. The displaced section was prevented from falling by the lightning conductor and has subsequently been removed and retained in store. The nature of the failure suggests a sudden structural fracture rather than gradual surface weathering. This incident highlights a potential latent risk at other decorative cross locations across the roofscape, where similar age-related stone decay and exposure conditions exist. Assessment of structural stability is recommended to assess ongoing safety issues and to assess if remedial works are required.

<p>Left 1a Removed stone cross at lightning rod position currently located in external store</p>

- 8.24. All gable crosses should be inspected by a specialist conservation stone mason based on the recent failure.
- 8.25. Repointing of the Organ Loft gable is recommended as a priority.

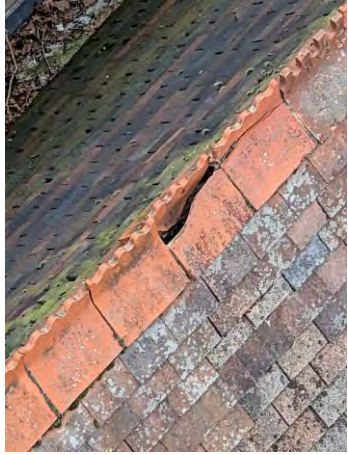
- 6.25. Pointing at parapet abutments has cracked and locally failed, increasing vulnerability to water ingress at these junctions. Near the ridge pointing is missing and masonry beyond is visible. (Photo 1b & 3a)

- 6.26. Repair of slipped and missing tiles, together with ridge and abutment repairs, will require specialist access arrangements. Whilst ongoing monitoring provides reassurance that water ingress is not currently acute, localised repair works should be planned within the quinquennium.

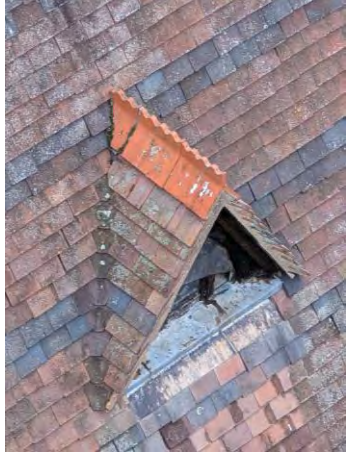
- 6.36. The central and east end dormer to the south nave roof, containing a leaded light window, is protected by a Perspex covering which has become broken and detached. Reinstatement is required. There appears to be missing sections of timber to the easterly dormer that should be repaired to prevent access by birds or bats. (photos 2a & b)
- 6.37. Associated timberwork shows signs of deterioration and requires repair. The dormer structure as a whole, including glazing, should be inspected to determine the extent of necessary remedial works. The principal immediate concerns are to prevent access by nesting birds and to avoid rainwater ingress.

- 6.38. Inspection and repair of all three dormers should ideally be undertaken within the quinquennium, or sooner if active leaks are identified.
- 6.39. Verge pointing to the dormers on the north roof slope appears relatively recent and remains tight. By contrast, verge pointing on the south side shows some cracking and weathering. Monitoring of the south-side verges over the quinquennium is recommended.

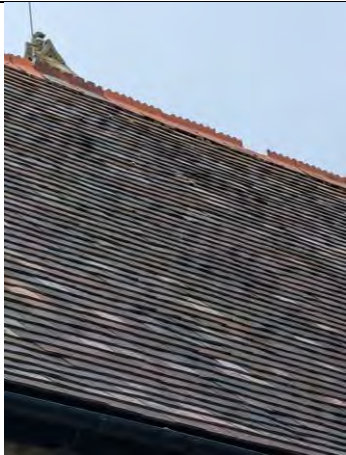
- 6.28. Several ridge tiles are fractured and unstable, presenting a risk of further detachment. A section of ridge tile was observed on the path below and is assumed to have fallen from this location. The ridge requires urgent attention from both a building maintenance and public safety perspective. (Photo 1a)
- 6.29. The concealed valley gutter was generally clear at the time of inspection, although some leaf accumulation was present. This is largely unavoidable given the roof geometry and

<p>Right 2b Missing timber infill</p> <p>Left 3a Section of ridge tile that has broken away and fallen</p> <p>Right 3b Cacking to mortar at abutment and debris build up in gutter</p>

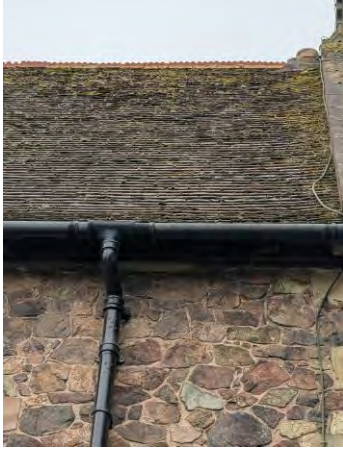
- 6.18. Ridge tiles exhibit the greatest level of deterioration, with several fractured tiles and evidence of frost damage. Localised defects are also evident near the ridge at the west end, where tiles and mortar haunching have become dislodged and are deteriorating adjacent to a partially capped flue. Repair in this area should be anticipated as part of programmed maintenance. (Photo 3a)
- 6.19. There appears to be one missing tile and a small number of slipped tiles across the roof pitch. Replacement of the missing tile and refixing of slipped tiles should be undertaken in due course to prevent water ingress.
- 6.20. Mortar haunching at the east gable abutment remains in fair condition.
- 6.21. Moss and debris accumulation against the west parapet should be cleared to prevent moisture retention and drainage obstruction. (Photo 4a)

<p>Left 4a Build up of moss on the roof slope</p>

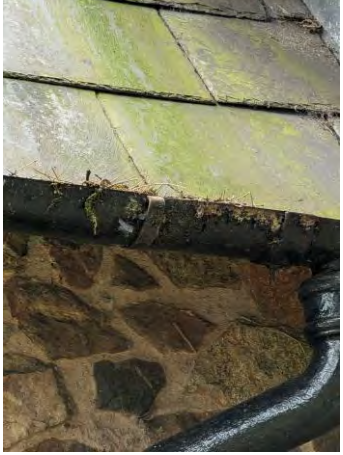
<p>Right 4b Evidence of repointing around stone and brick as well as debris build up in the valley</p> <p>Left 5a Decoration to rainwater goods needing review and some localised clearing.</p>

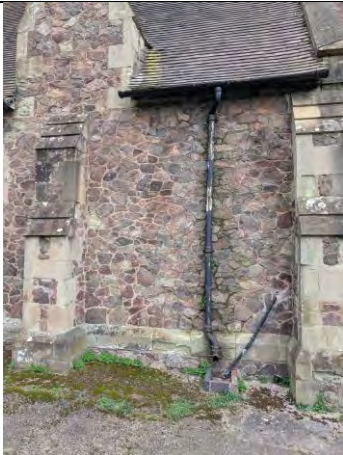
- 7.4. At the sacristy roof outlet there is clear evidence of persistent overtopping. Heavy biological growth and staining are present to adjacent masonry directly below gutter level, with moss and algae colonisation consistent with chronic wetting. Water tracking is visible on the stonework beneath the outlet, together with concentrated staining at the wall head and eaves interface. This pattern indicates rainfall events exceeding the discharge capacity of the outlet, likely due to partial blockage and restricted downpipe flow (Internal inspection correlates with these observations. Damp penetration is evident to the sacristy wall, together with localised plaster failure and detachment.

Moisture staining is consistent with prolonged saturation. The relationship between external overflow and internal dampness is strongly evident). (Photo 6a)

- 7.5. Persistent overtopping is accelerating masonry saturation and salt mobilisation, contributing to mortar joint erosion and biological colonisation of stone surfaces. Internally, continued wetting is promoting plaster decay and loss of decorative finishes. If unaddressed, ongoing moisture loading is likely to result in deeper fabric deterioration and potential timber decay at concealed interfaces.
- 7.6. Overall, the system continues to function but performance is compromised at outlets and drainage points where maintenance has been insufficient. Localised defects will be actively contributing to moisture ingress and associated fabric deterioration.

<p>Right 5b Proximity of tree to the roof and delamination of stone surround</p> <p>Left 6a Evidence of outlet blockage. Water staining to wall. Decoration needed to rainwater goods.</p> <p>Right 6b Possible lean to the chimney structure, vertical split to face of sandstone near eaves.</p>

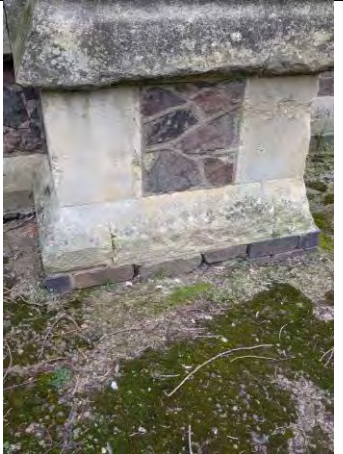
<p>Right 7b Large section of delamination at the plinth. Modern replacement or indent to the left.</p> <p>Left 8a Brickwork at ground level requires repointing in areas</p>

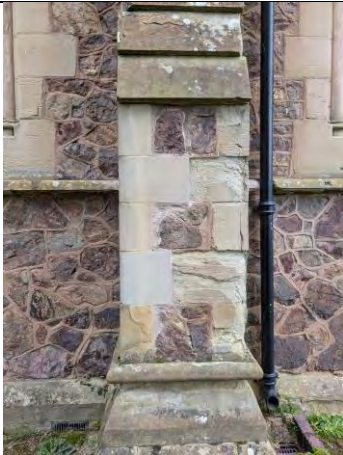
<p>Right 8b Example of delamination that results in water trap. These should be removed to prevent further decay and issues with falling.</p> <p>Left 9a An example of some of the greater stone deterioration at the butress locations</p> <p>Right 9b Open joint in coping, loss of mortar to Malvern stone, some loss of stone to both the decorative cross and coping.</p>

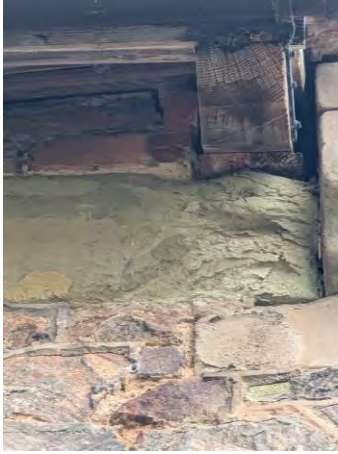
<p>Left 10a Open joints and loss of stone surface locally suggests a weathering issue and potential backfall in gutter.</p>

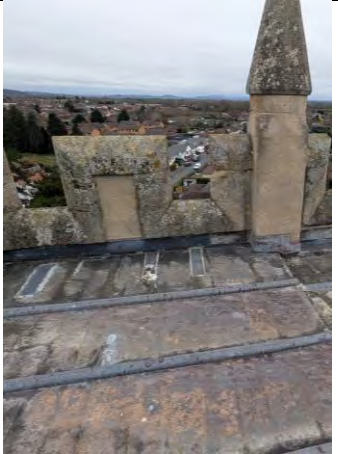
<p>Right 10b Loss of stone and open joints to some of the stone embrasures</p> <p>Left 11a Tower roof lead servicable but aging and showing signs of patch repair. Organic build up associated with shallow falls.</p>

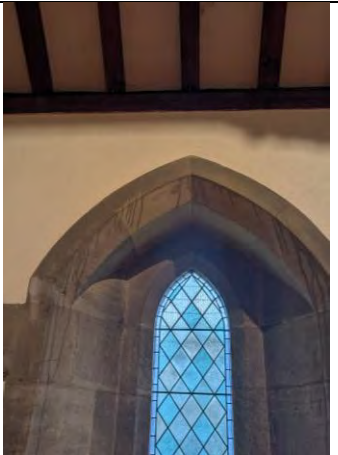
<p>Right 11b Broken glass to tower window in approx. 4 locations</p> <p>Left 12a Water staining to stone surrounds internally, possibly caused by condensation run off.</p> <p>Right 12b Stability of cracked render should be assessed and loose sections removed</p>

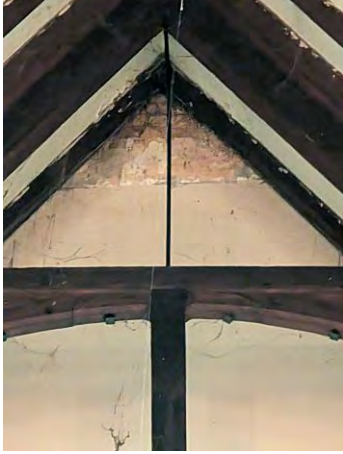
<p>Left 13a Evidence of damp at ridge. Plaster appears to have been cut back locally.</p>

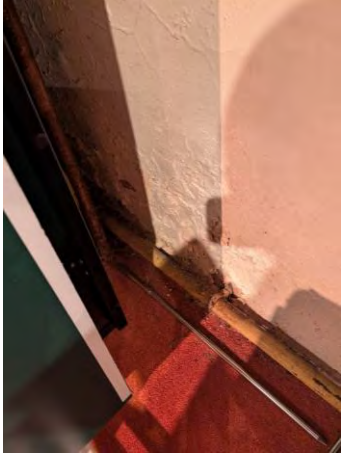
<p>Right 13b Some evidence of damp at cill of dormer window</p> <p>Left 14a Issues with damp at low level and where heat sources and ventilation are restricted</p>

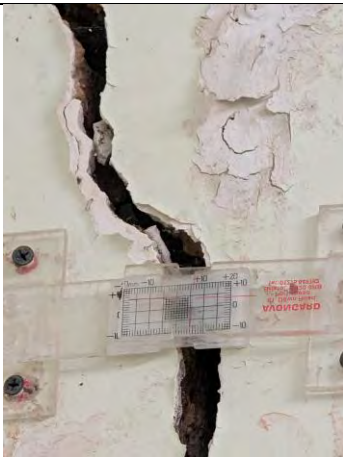
<p>Right 14b Typical south side loss of stone at base of windows internally and example cement pointing</p> <p>Left 15a The large crack in the sacristy wall appears to show signs of further movement</p> <p>Right 15b Evidence of damp near external downpipe with impermeable paint finish peeling showing red paint below</p>

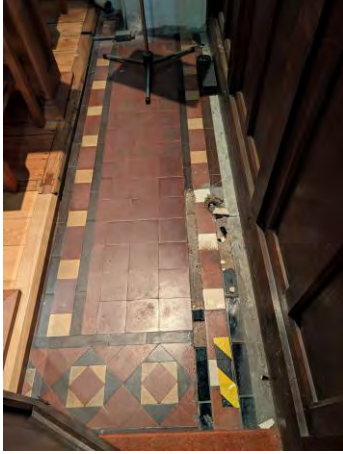
<p>Left 16a Loose and damaged floor tiles within chancel</p>

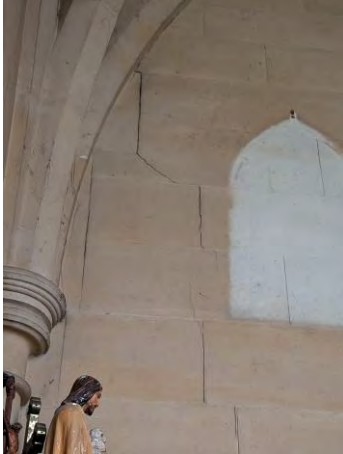
<p>Right 16b Extract grille to ceiling needs refixing</p> <p>Left 17a Some minor cracking to the base of the tower should be monitored</p>
