Report on the Quinquennial Survey for 2026

St. Matthias, Malvern Link

QUINQUENNIAL INSPECTION REPORT

Church Name: Church of St Matthias

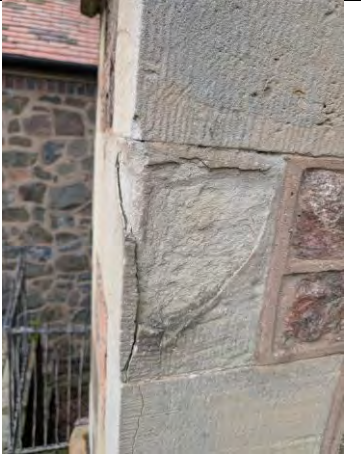
<p>Right 7b Large section of delamination at the plinth. Modern replacement or indent to the left.</p> <p>Left 8a Brickwork at ground level requires repointing in areas</p>

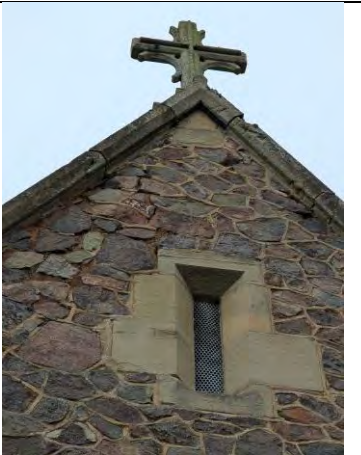
<p>Right 8b Example of delamination that results in water trap. These should be removed to prevent further decay and issues with falling.</p> <p>Left 9a An example of some of the greater stone deterioration at the butress locations</p> <p>Right 9b Open joint in coping, loss of mortar to Malvern stone, some loss of stone to both the decorative cross and coping.</p>

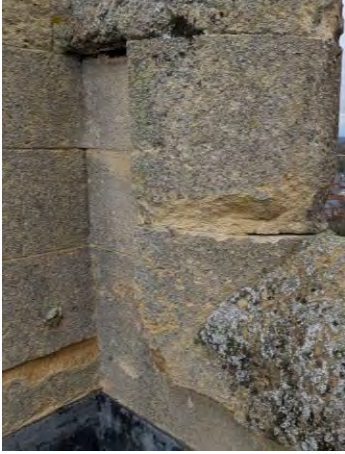
<p>Left 10a Open joints and loss of stone surface locally suggests a weathering issue and potential backfall in gutter.</p>

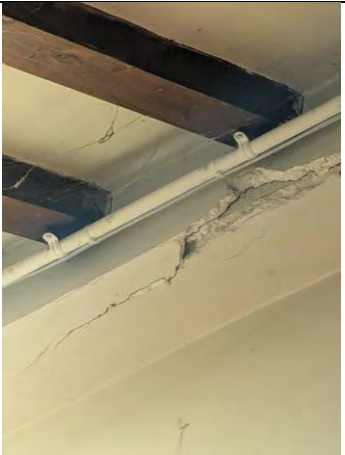
<p>Right 11b Broken glass to tower window in approx. 4 locations</p> <p>Left 12a Water staining to stone surrounds internally, possibly caused by condensation run off.</p> <p>Right 12b Stability of cracked render should be assessed and loose sections removed</p>

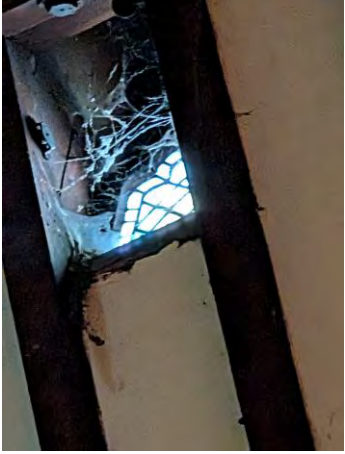
<p>Left 13a Evidence of damp at ridge. Plaster appears to have been cut back locally.</p>

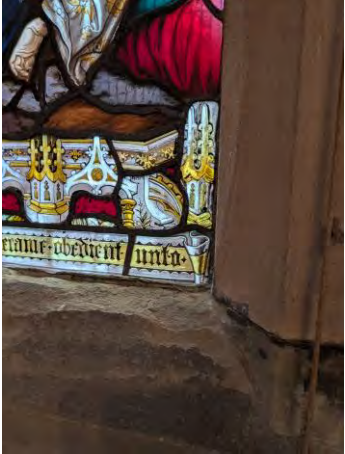
<p>Right 13b Some evidence of damp at cill of dormer window</p> <p>Left 14a Issues with damp at low level and where heat sources and ventilation are restricted</p>

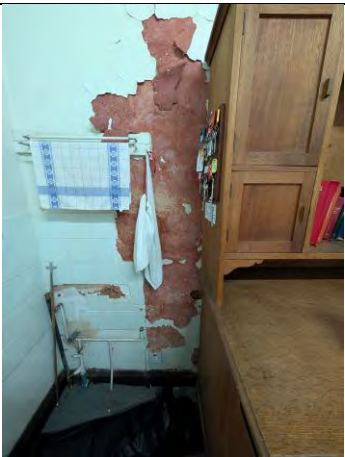
<p>Right 14b Typical south side loss of stone at base of windows internally and example cement pointing</p> <p>Left 15a The large crack in the sacristy wall appears to show signs of further movement</p> <p>Right 15b Evidence of damp near external downpipe with impermeable paint finish peeling showing red paint below</p>

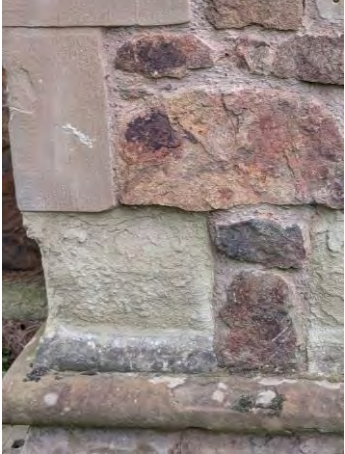
<p>Right 16b Extract grille to ceiling needs refixing</p> <p>Left 17a Some minor cracking to the base of the tower should be monitored</p>

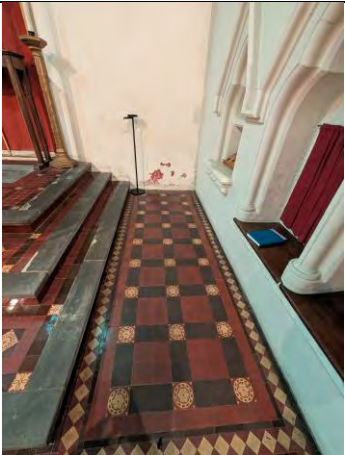
<p>Right 18b Example where loss of stone is above 15mm and an indent should be introduced</p> <p>Left 19a Damp section of tent fabric identified at the last QQ does not appear to have worsened</p> <p>Right 19b Low level damp at the gable wall of the chancel</p>
